NATURAL RESOURCE DAMAGE ASSESSMENT AND RESTORATION
PLAN/ ENVIRONMENTAL ASSESSMENT (DARP/EA) FOR THE
RIVERVIEW, FLORIDA PHOSPHOGYPSUM STACK DISCHARGE,
SEPTEMBER 5 – 6, 2004

U.S. Department of Commerce
National Oceanic and Atmospheric Administration
Southeast Regional Office
263 13th Avenue South
Saint Petersburg, Florida 33701

Florida Department of Environmental Protection
Southwest District - TAMPA
13051 N. Telecom Parkway
Temple Terrace, Fl. 33637

August 17th, 2012

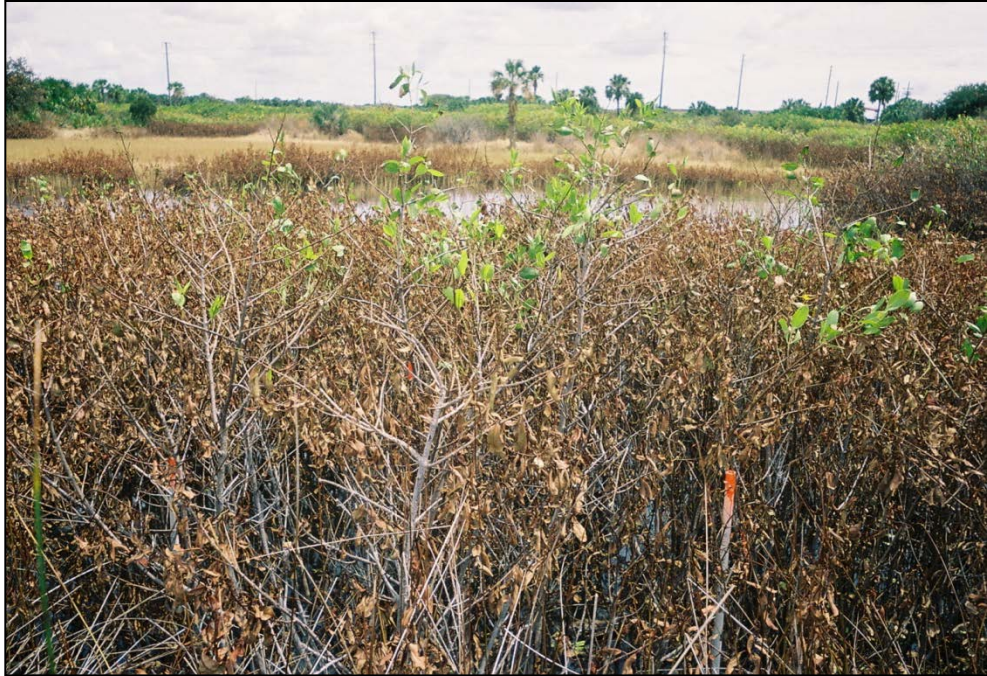
Data collected in April, 2007 and reported in the Technical Data Report Supplement Number Two, August, 2007, show that most of the impacted tidal marsh areas recovered or were at a minimum of 50% recovery. Follow up investigations and photographic documentation in fall 2009 confirmed that the natural recovery of the affected marsh did proceed as expected and in some cases even showed the progress of natural succession from cordgrass marsh to mangroves (Figures 3 and 4).

Figure 3. Damaged mangrove and tidal marsh south side of South Archie Creek Canal and east of Old Hwy 41 in “Severe Impact Area”. Photo taken September 13, 2004.

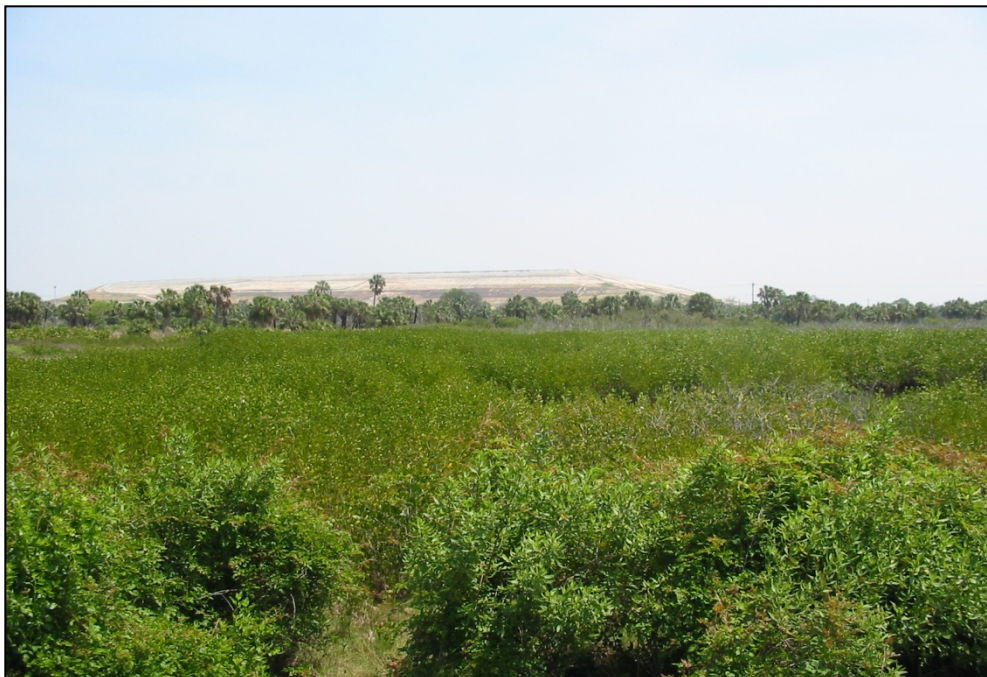
Figure 4. Damaged mangrove and tidal marsh north side of South Archie Creek Canal and east of US 41 in “Severe Impact Area”. Photo taken April 19, 2007.

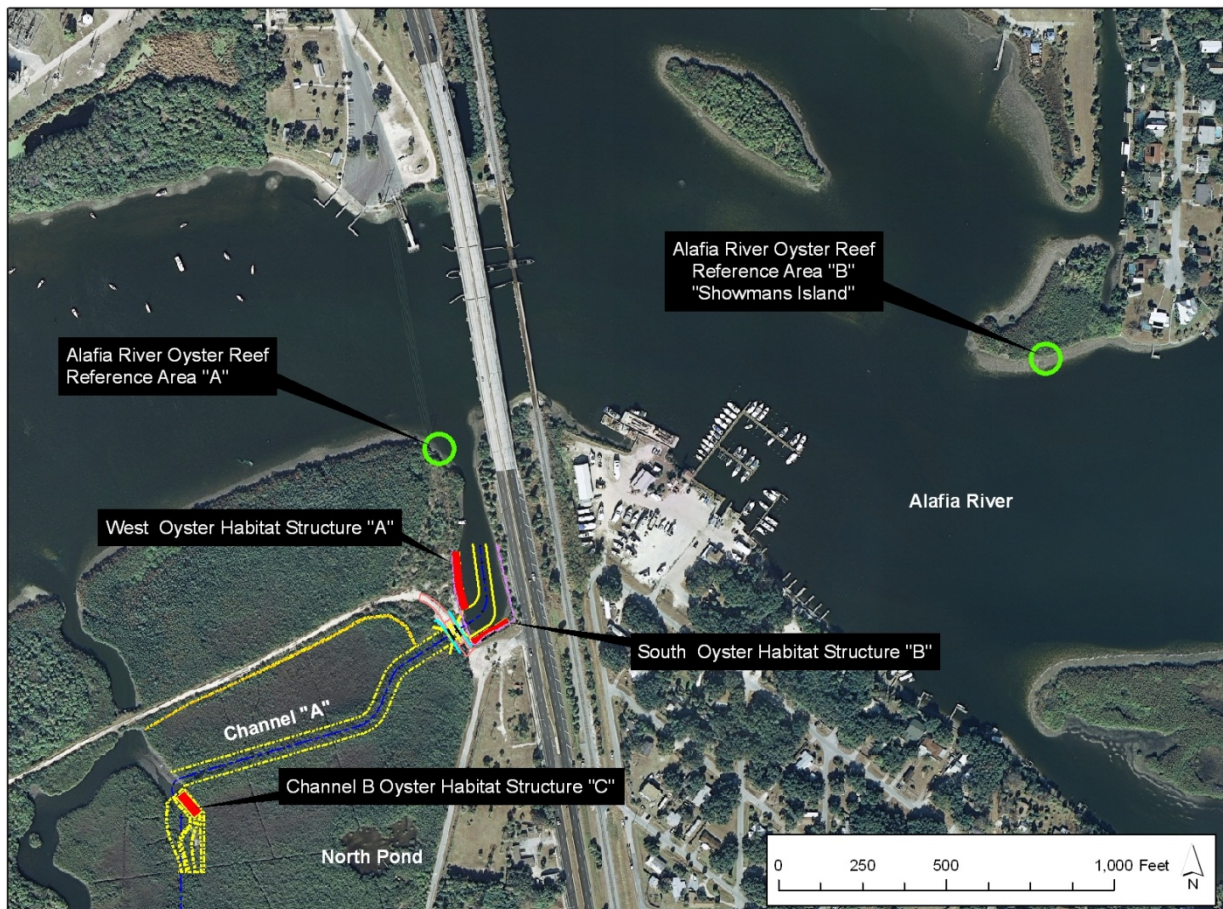
William's Park on the Alafia River was the original site selected to conduct reference monitoring for oyster growth and survival in the Alafia River and the Restoration Areas. However, observations on several occasions of people harvesting large oysters at Williams Park and associated biota to use as fishing bait has made this site not acceptable. LES located acceptable oyster reefs at the opening of Giants Fish Camp Basin to the Alafia River and at Showman's reef, a created oyster reef just up river from the Giant's Fish Camp location. Both of these sites are acceptable to the Trustees as reference sites and permanent transects, as per the DARP/EA and SOW methodologies have been established. Nothing more has changed from the original monitoring methodologies other than the reference site locations. Please refer to the updated graphic below for the site locations. This figure should replace Figure 9 in the Final DARP/EA. The SOW has the updated language and graphic.
